SUBJECT: A heavy equipment spotter died when he was backed over by a front-end loader inside a trash collection transfer station.

SUMMARY
California FACE Report #01CA012

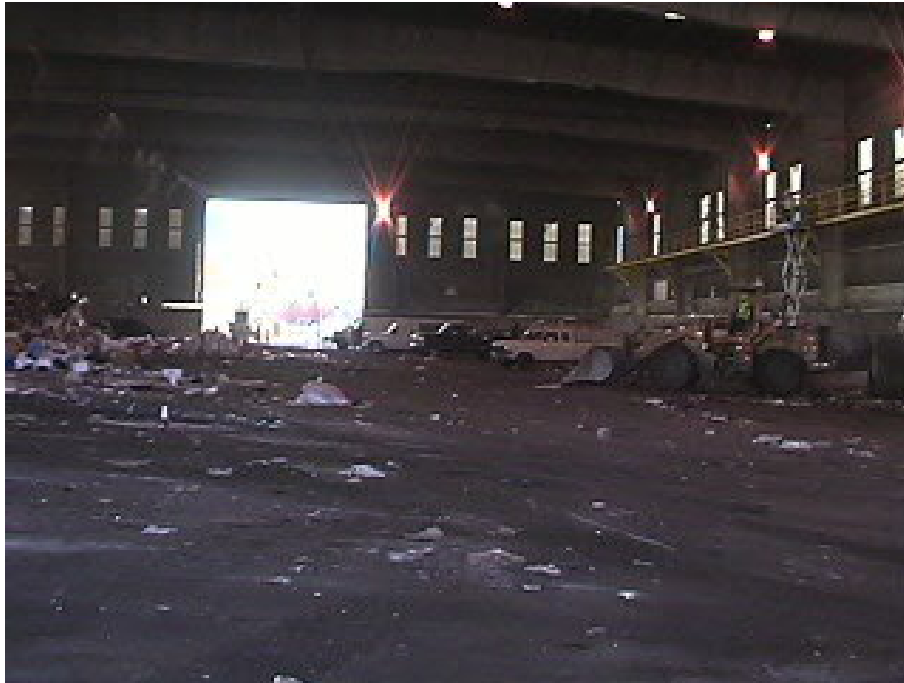
Exhibit #1

View from inside the transfer station looking at the east entrance.

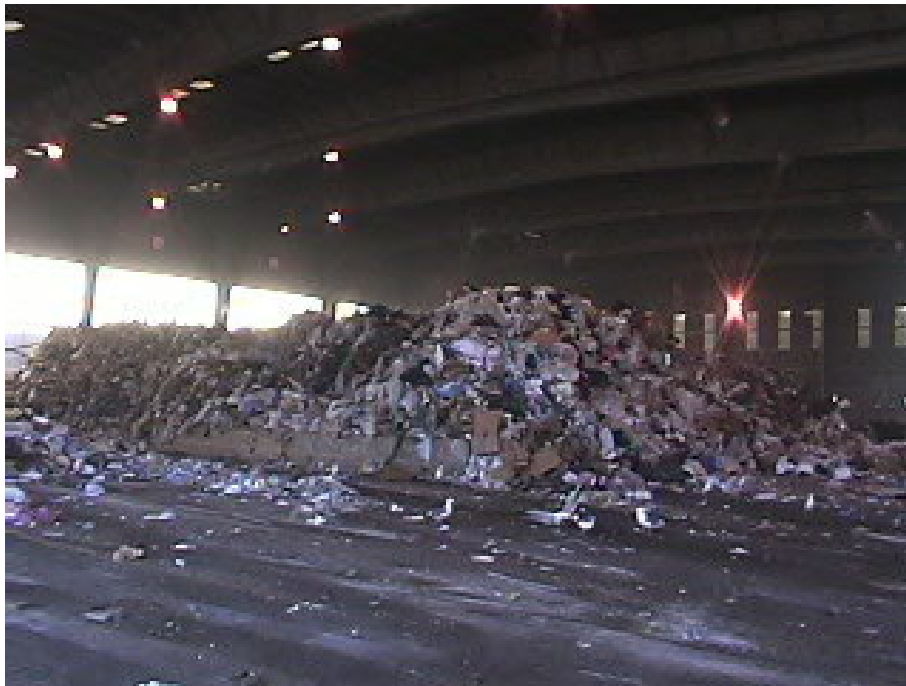
Exhibit #2

View from inside transfer station looking north at dumped waste in a designated bin.

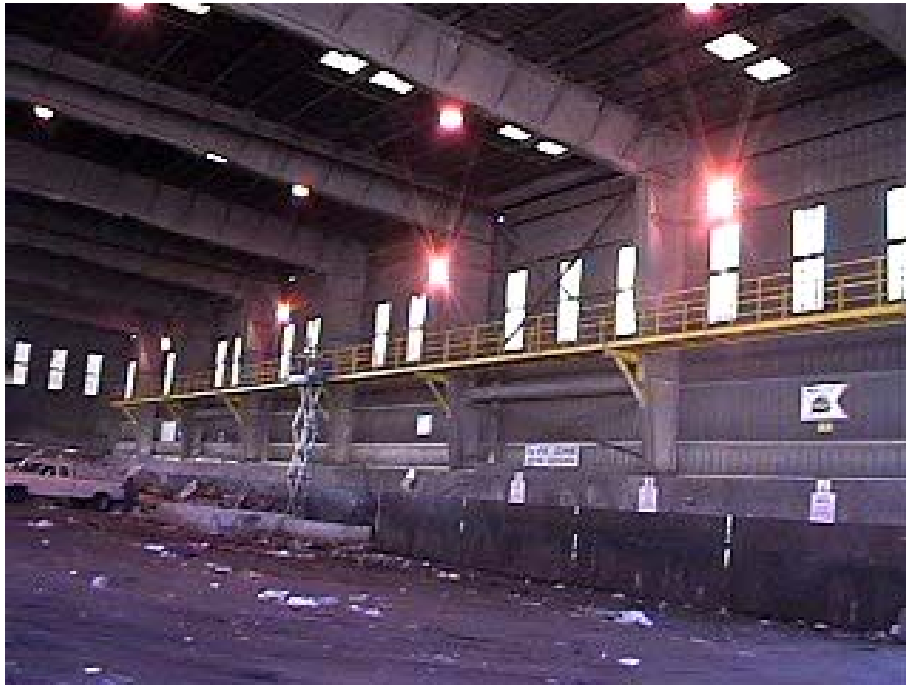
Exhibit #3

View from inside the transfer station looking at the south wall where trucks park to clean out.

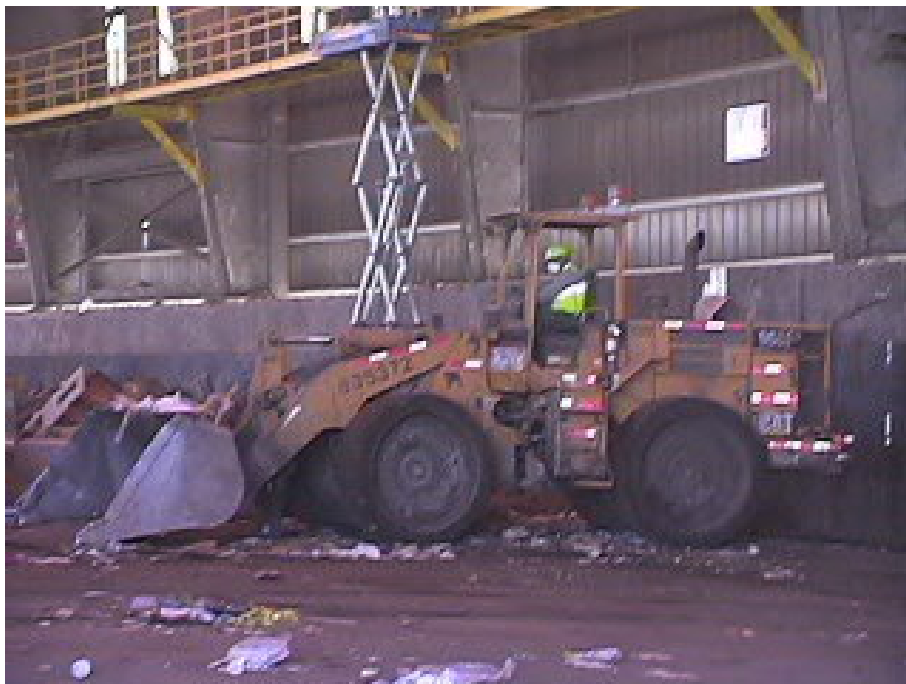
Exhibit #4

View of the left side of the front-end loader involved in the incident.

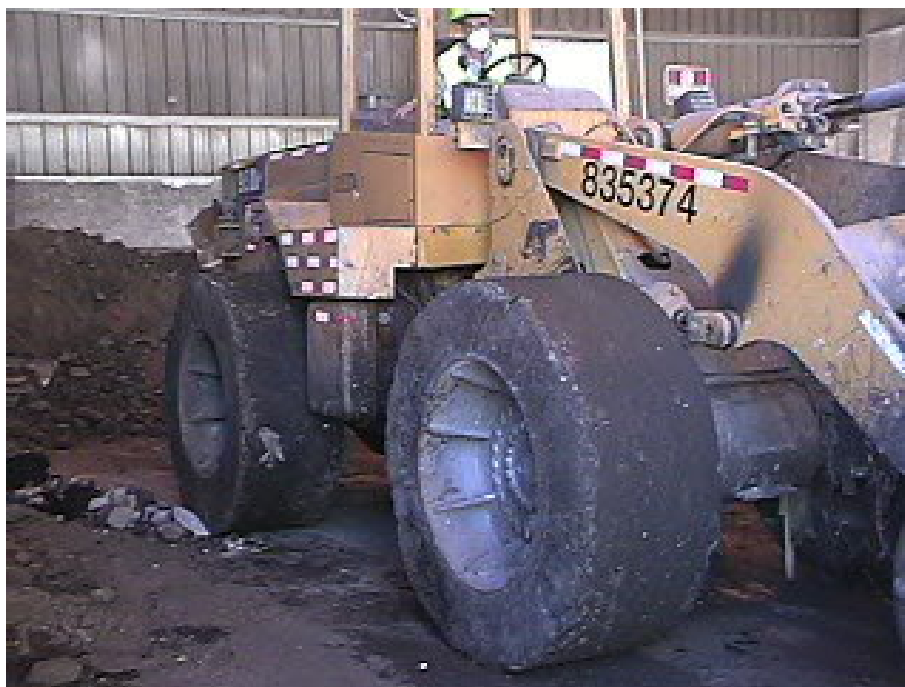
Exhibit #5

View of the right side of the front-end loader involved in the incident.

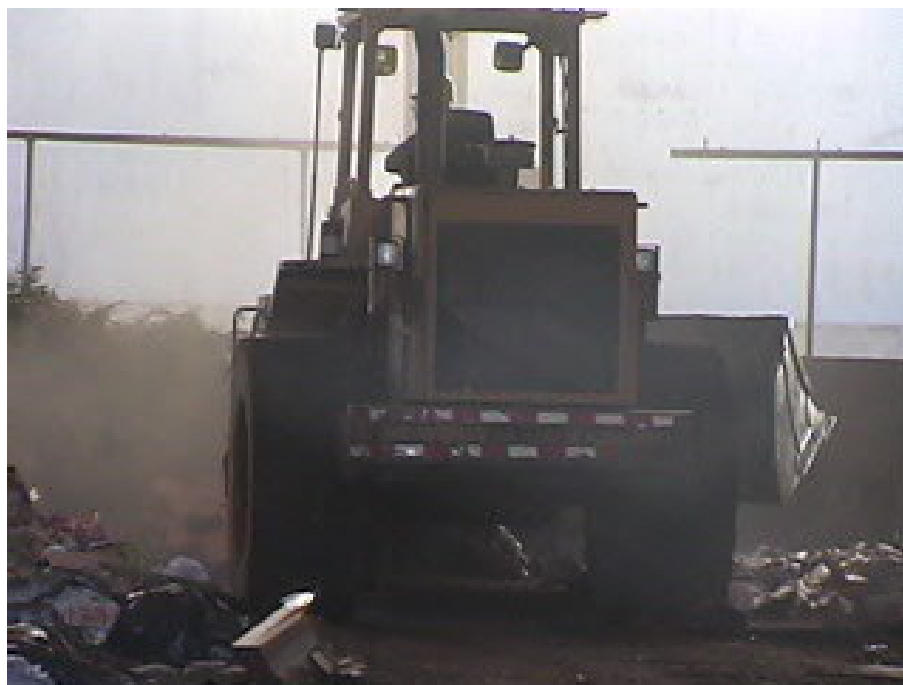
Exhibit #6

View of the front-end loader involved in the incident pushing waste.
